# Event Analysis Tutorial

## Part 2: Answer Key

David Costello, Schweitzer Engineering Laboratories, Inc.

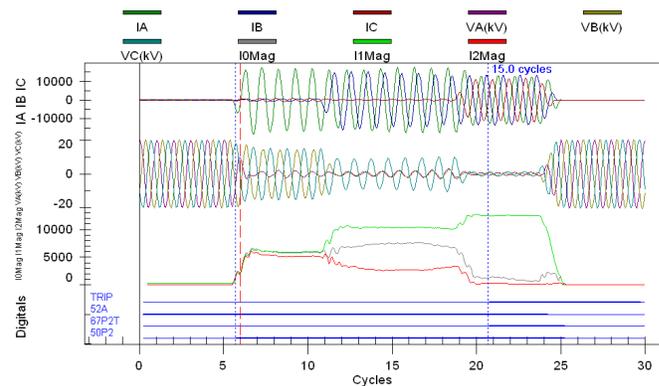
Fig. 1. Distribution Feeder Fault (2 – Distribution Feeder Fault 351S-6.cev)

Lightning arresters, one per phase, are positioned on the top of the steel support structure. Each arrester is connected by a jumper to the phase conductor. A bird caused a fault near one lightning arrester, which caused its jumper to blow loose and contact other phases.

- II-a Before the fault, in what direction is power flowing?  
Power is INTO the bus or in the reverse direction.
- II-b What is the system phase rotation?  
ABC.
- II-c What type of fault occurred?  
This is an evolving fault on the feeder (forward direction). It starts as an AG fault, evolves to an ABG fault, and then finally evolves to a three-phase fault.
- II-d What protection element within the relay caused the trip?  
67P2T—a nondirectional phase overcurrent definite-time delay element.
- II-e How long did it take for the relay to operate?  
15 cycles.
- II-f How long did the breaker take to clear the fault?  
About 3.5 cycles.

II-g Did the relay and protection system operate correctly and as expected?  
 Yes.

Note in Fig. 1 that the phase fault current is largest during the single-line-to-ground fault period. In Fig. 2, the phase fault current is largest during the three-phase fault period.

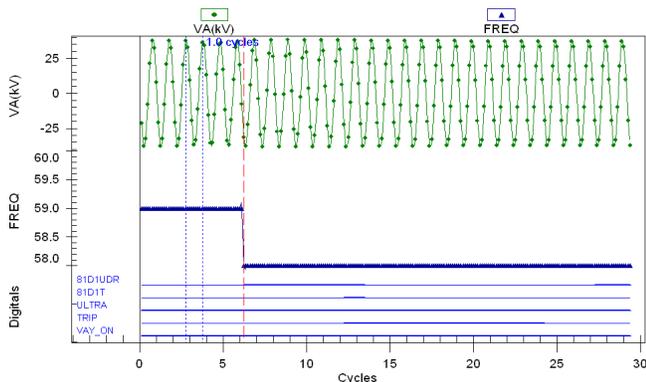
Fig. 3. Frequency Test 1 (3 – Frequency Load Shed Test One 451-5.cev)

Three problems were noted by technicians. First, the output contact used by the underfrequency element 81D1T chattered continuously after the frequency was lowered below the set point, and it would not stop until the frequency was returned to normal. Second, the trip time for the underfrequency event was slightly longer than expected. Third, the frequency metering stopped tracking at 58.0 Hz, despite the test set being lowered below this level.

- III-b At what point in the event data did the test set actually change frequency?  
 Just before Cycle 3 in Fig. 3, the frequency of the applied voltage begins to change. We can determine this because samples begin to hit the steady-state waveform at different points on the curve. There is always a slight lag in frequency tracking in a digital relay and the actual frequency of the input signals. Frequency tracking, in most relays, determines sampling rates. So when the sample points start moving to different points on the curve or when  $x$  samples per cycle do not get us back to the same point on the waveform we know the input signal frequency is changing, and the frequency tracking and sampling rate of the relay are drifting slightly.

A test set timer, measuring the difference in time between the state change and the assertion of 81D1T, would measure 3 to 4 cycles longer than the 6-cycle delay expected. This is due to the suspension of frequency tracking, which, in turn, disables frequency elements (according to the instruction manual Figure R.1.58).

Within 1 cycle of the trip asserting, the frequency elements deassert. Within 3 cycles of the trip deasserting, the frequency elements pick up again. It appears the trip logic affects frequency elements from these test results. In the second test, the trip equation is set to NA, and the frequency elements do not cycle. In fact, frequency tracking in the SEL-451-5 is suspended during faults as determined by the trip equation—when TR is a logical 1, FREQOK is driven to a logical 0. This disables the frequency elements.

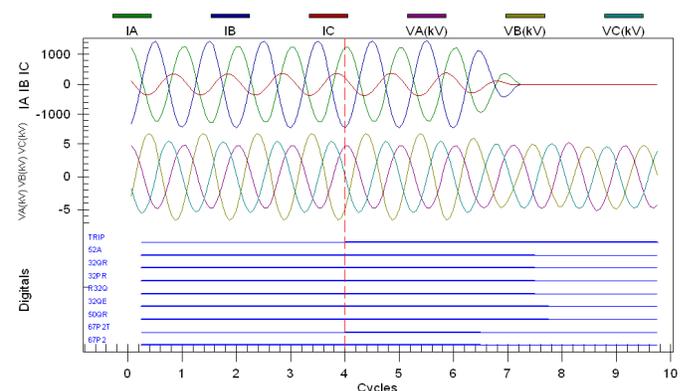
Fig. 6. Main Breaker Data (4 – Main Breaker Directional Element 351A.cev)

The utility had a lightning arrester failure at a customer-owned substation several terminals away from this plant. The 67P relay tripped for this fault.

- IV-d Is this relay tripping response expected or a misoperation? There was a fault on the utility system (which is a reverse fault to this relay). So, technically, the relay did as it was told: see the reverse phase or ground faults and trip. However, it was intended to trip after a fair time delay for reverse power flow or as backup for a high-side fault when the utility high-side breakers were open. The utility had a failure to clear the fault at high speed, so the prolonged fault time exposed this problem. It is safe to say no one intended this relay to be so sensitive and to see an LG fault several line sections away.

- IV-e What is the root cause? The problem for this application is the relay directional element sensitivity. An electromechanical phase relay directional element operates like a power meter. With high load INTO the plant during an external fault, the high load overpowers the reverse fault sensing, so the overall decision is forward. In SEL-351 Relays, the phase overcurrent element has two distinct areas of logic. First, high forward load into the plant exceeds the phase overcurrent magnitude pickup. Second, a separate directional element looks for the fault location. For unbalanced faults, the relay uses negative-sequence quantities, which are provided by unbalanced current flow through motors and other loads in the plant. In other words, forward load into the plant picked up the phase overcurrent element (magnitude sensor) and the reverse negative-sequence element saw the fault

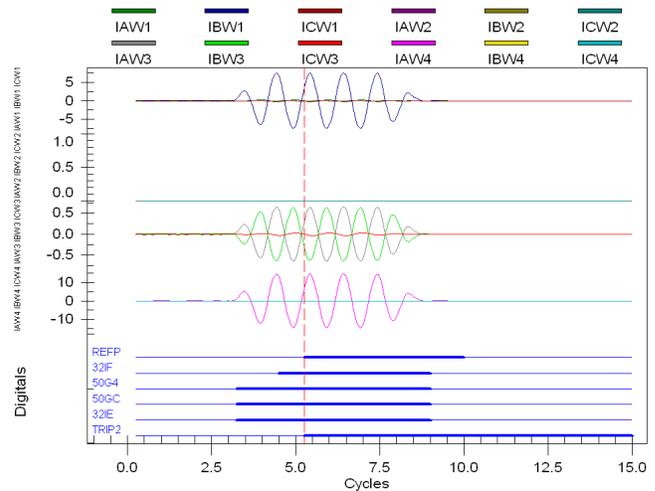
Fig. 11. REF Application (6 – Transformer REF 387-6.cev)

- VI-g A CT wiring problem is suspected. Can you prove which winding has the error?  
We know that the W1 feeder CT that experienced the external fault is connected correctly because the IB current on W1 is out of phase with the IB current on W3, the transformer high-side CT. That means the X0 bushing CT is connected backward or with incorrect polarity. The drawing in Fig. 10 is correct, so the error is in field wiring or the CT in the transformer tank is installed backward. Three recommended ways to ensure that the REF CTs are installed correctly are primary injection testing, standard CT polarity testing, or leaving the REF tripping disabled until the first system fault record can verify proper connections.

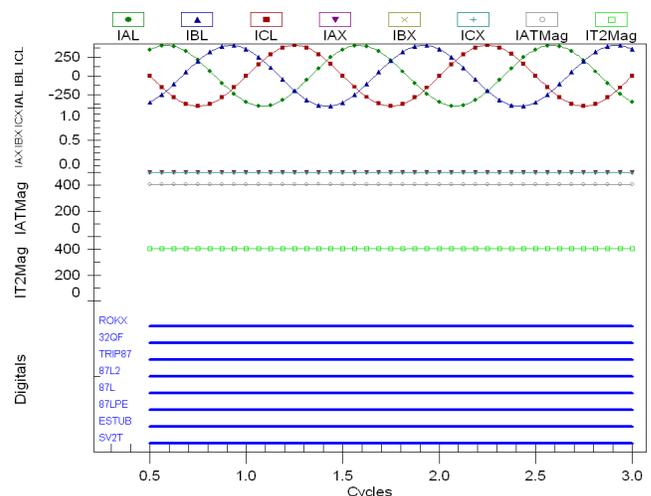
Fig. 15. Line Current Differential Commissioning (8 – Transmission Line 87L Test 311L.cev)

No. The phase rotation setting, PHROT, is ACB, and the applied phase rotation is ABC. This will cause errors in positive- and negative-sequence calculations within the relay.

We may suspect the Terminal A relay has a problem, because loopback tests work at the Remote B terminal. However, we are told that previous fault records exist that showed correct operation and that the relays have been in service for some time. We know that the self-test alarm is not asserted. We know that the channel monitor is okay, meaning the two terminals are communicating. And we are experiencing identical problems in two relays, primary and backup, at Terminal A. It is unlikely that two relays would fail identically at the same time. Because the two relays at the local end are behaving similarly, we should concentrate there.

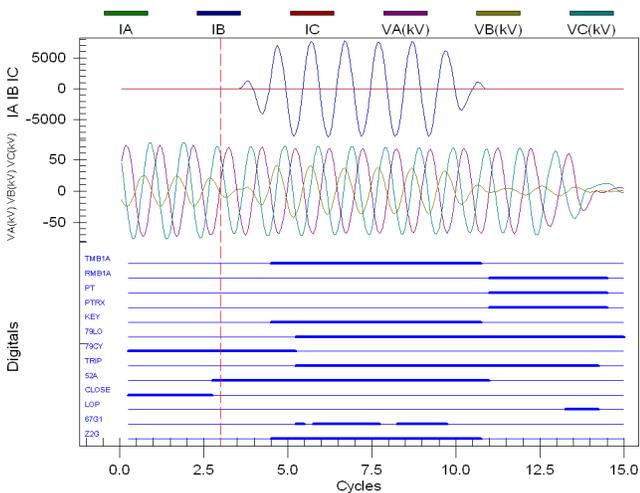
Fig. 18. Third Event, Terminal A (9 – A Delayed Fault Clearing 3rd Event 311C.cev)

Fig. 18 shows an automatic reclose. It was determined that human error caused a hot-line tag to be taken on the wrong line and not the energized line that the crew was working under. Luckily, no one was injured in this event.

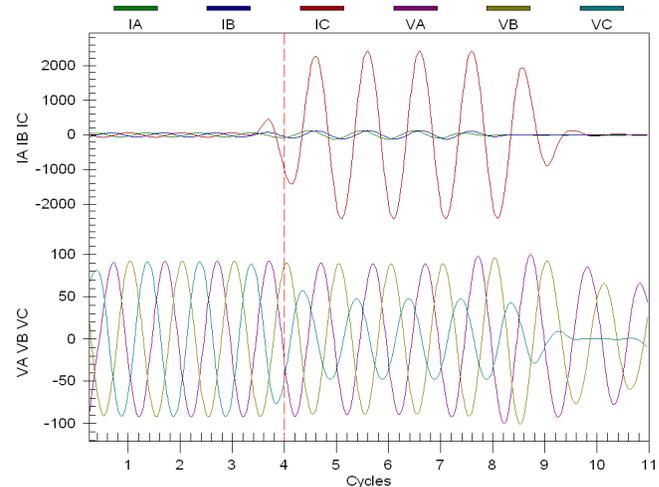
Fig. 22. LG Fault (10 – Double End Fault Location R 121G.eve)

A fault occurred on an 82-mile-long 161 kV line. The left terminal (R) provided a fault location estimate of 13.95 miles (from the left). The right terminal (S) provided a fault location estimate of 56.5 miles (from the right).

Engineers know these estimates are in error because they do not provide a common location on the line, do not add up to 82 miles, and do not match the actual location of the fault, as determined by visual inspection and damage.

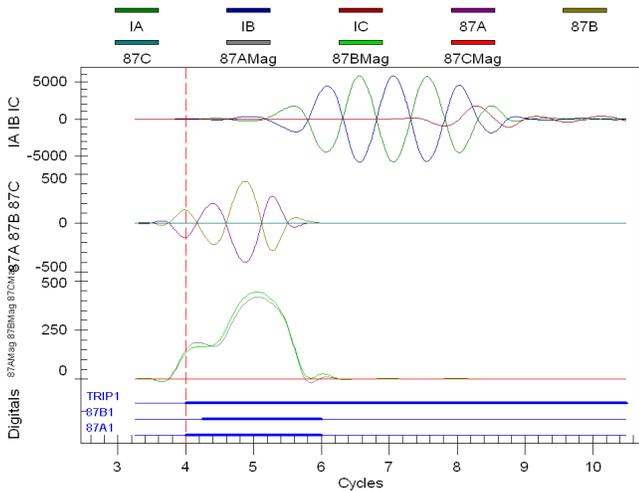
Fig. 23. Filtered Bus Differential Operation (11 – High Impedance Bus Trip 587Z Filtered.cev)

- XI-a Was this an internal or external fault?  
Based on the magnitude of the voltage signals, there is no question—this was definitely an internal bus fault.
- XI-b What element caused the trip?  
87A1 and 87B1 high-impedance differential elements.
- XI-c In the oscillograph data, why does the current signal seemingly lag or follow the voltage?  
There is current during the first 1 and 2 cycles, but it is extremely small. In the raw waveform, we can see that the secondary current signals are very distorted as well. The small magnitude is due to the 4000-ohm burden through which the CT secondary current is having to travel for an internal fault. When the relay trips the bus lockout, a contact from the lockout is used to short-circuit the high-impedance input on the relay. When this occurs, the circuit burden is drastically reduced and the secondary current through the relay increases.

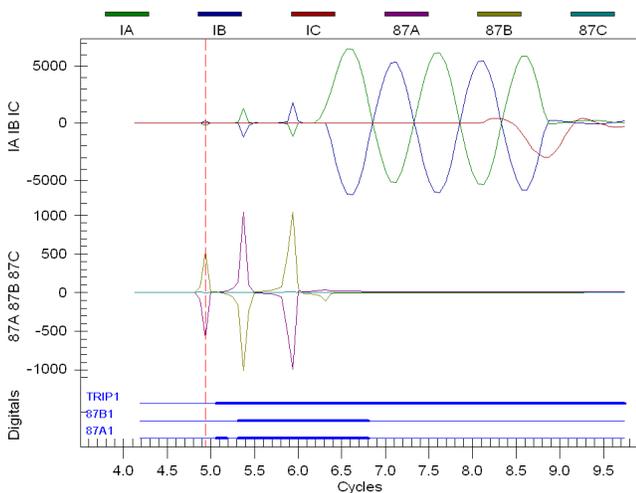
Fig. 24. Raw Bus Differential Operation (11 – High Impedance Bus Trip 587Z Raw.cev)

XI-d Can you explain the difference in waveforms in the raw event data (sharp peaks versus smooth sinusoids)? Consider that a C800 CT is rated so that it produces rated voltage with 20 times nominal current (5 A) flowing through a rated burden of 8 ohms. Now, consider that for an internal fault, that same CT is driving current through a burden of 4000 ohms, or 500 times greater than the rated burden. The CTs will saturate badly, and the sliver or spikes of current and voltage in the raw event are evidence of that. Nonetheless, as long as we do not use less than a C200 CT, the scheme remains secure.

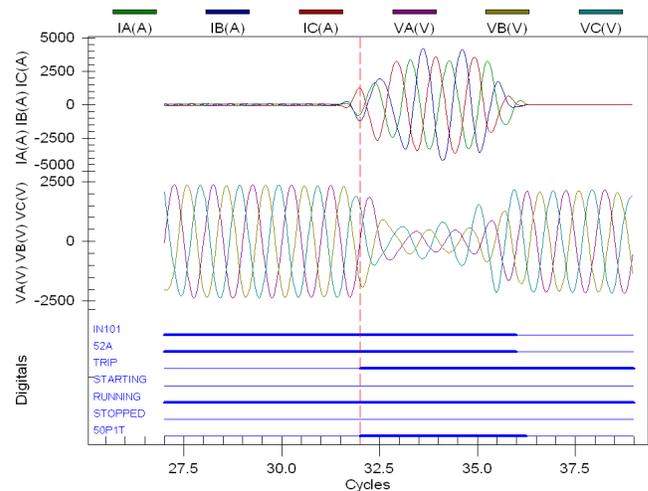
Fig. 25. Motor Trip (12 – Motor Trip 710.cev)

- XII-b** Can you prove the event was not caused by a load jam or jammed router?  
The current magnitude during the event is much greater than the motor locked rotor current (a setting) and is therefore due to a fault.

- XII-d** What element caused the trip?  
The 50P1T element tripped. This is based on a 50PIP pickup setting of 13 multiples of full load A, or 1235 A primary. The 50PID delay is set to zero. Motors and their cable leads are typically protected by an instantaneous phase overcurrent element in a motor relay.

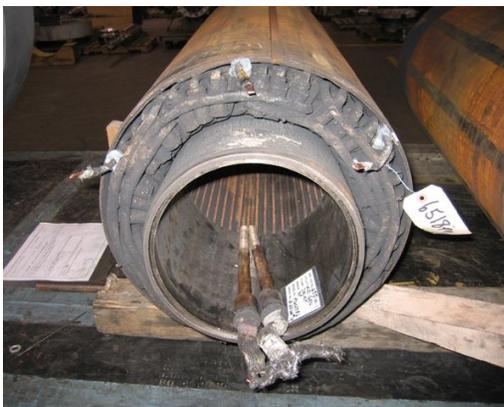
**Photo of stator winding where leads are attached. The motor developed a three-phase fault at this location.**

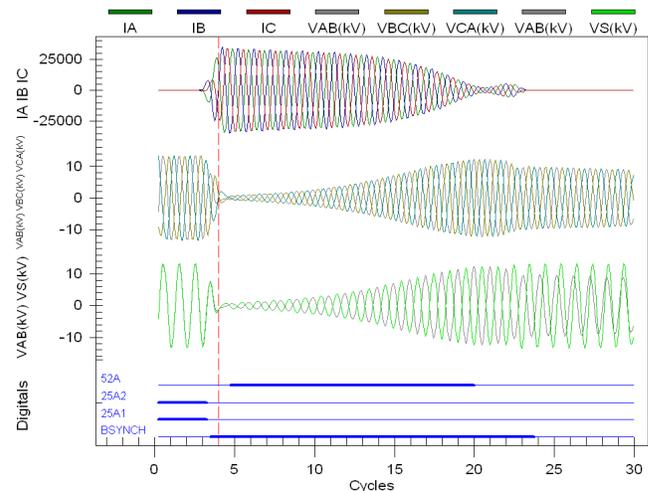
Fig. 26. Generator Close (13 – Generator Close 300G.cev)

- XIII-c** What conditions could produce this much current at the terminals of this generator?  
A three-phase fault could produce high currents. However, the currents are decreasing, and voltages are increasing. A large voltage difference across the generator (and step-up transformer, in some applications) impedance caused by an out-of-synchronism close could also produce these high currents. The voltages are also returning slowly to normal, indicating the two systems are synchronizing.

- XIII-d** If this was a fault, what would the current magnitude look like from the generator?  
For faults, we expect to see three distinct periods, which differ in current magnitude. The generator impedance changes and increases over time. The subtransient reactance period (roughly 2 cycles) produces the largest current and is followed by the transient reactance (exponential decay), which is followed finally by the steady-state or synchronous

reactance (which can be less than full load A of the generator). The current in this event does not follow that expectation, and dramatic decay occurs. Therefore, we can conclude that this was not due to a fault.
