CASE STUDY

Conway Corporation—Conway, Arkansas

Relay's Event Reports Offer Powerful Data for Diagnosing Power System Problems

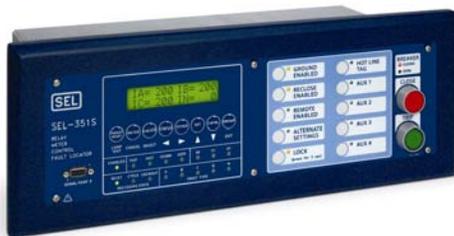
Figure 2—The SEL-351S Protection and Breaker Control Relay is deployed by Conway Corporation’s Electric Department for feeder protection and recloser applications. The SEL-351S recorded the event report used to determine the source of the voltage and current problem.

The Conway Electric Department uses SEL-351S-7 and SEL-351S-6 Protection and Breaker Control Relays and SEL-551 Overcurrent/Reclosing Relays in its distribution substations. The SEL-351S-7 Relay is used on the feeder main, with the SEL-551 as backup. The SEL-351S-6 Relays provide feeder protection as well as reclosing.

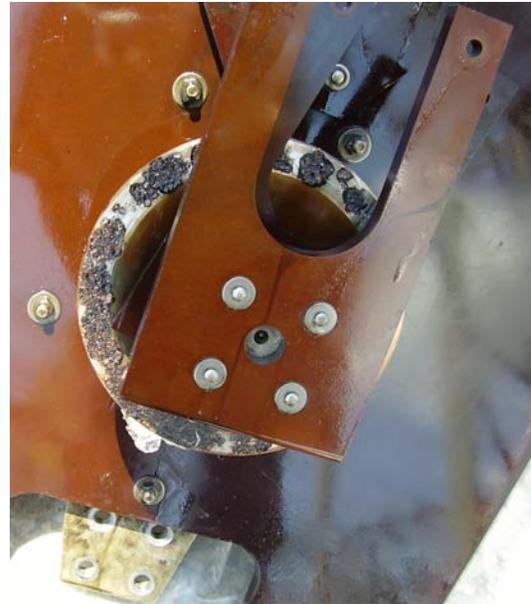
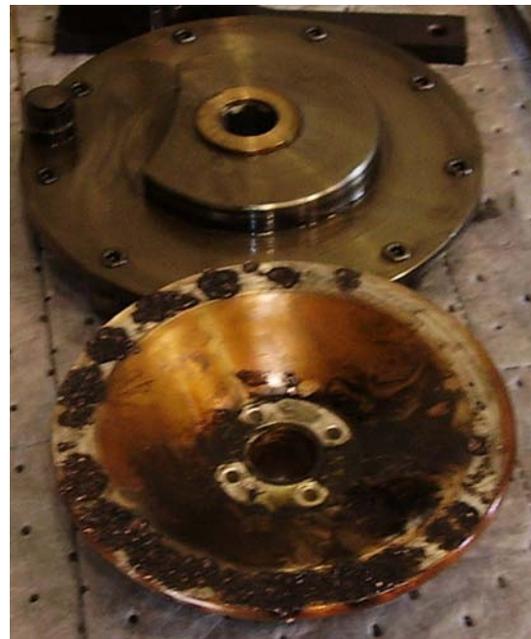
Perry said the event records showed a decrease in C-phase current (IC) and C-phase voltage (VC), while A-phase and B-phase currents increased. “This occurred on two feeders. I suggested testing their transformer, which was a tap changer. When we inspected it, we found that the rotary tap changer contacts were severely worn.

Figure 3—Inspection of the utility transformer revealed the damage caused to the rotor assembly (shown above) and the rotor of the tap changer (shown below) caused by arcing.

“What was causing the problem was that the C-phase on the utility transformer was opening up, and the industrial customer was in single phase,” he added. “It wasn’t a complete opening; actually, the moving contacts in the transformer were arcing. That’s why the event report oscillograph showed the collapsed C-phase voltage and the collapsed C-phase

current, just as if you were removing the voltage off of the load C-phase. There was a three-phase system within the industrial facility that was actually single-phasing, which could cause equipment damage. And of course, the arcing of the transformer caused damage to the contacts.”

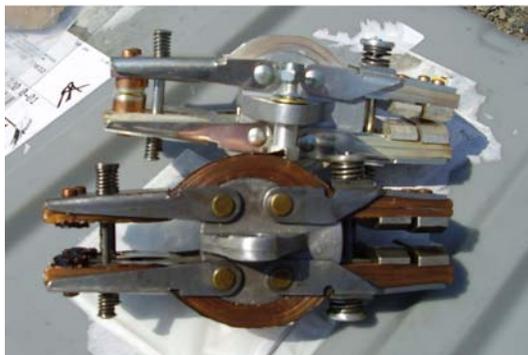
Figure 4—The old bridge contact is shown in the lower portion of this on-site photo. The contacts at both ends are severely worn. The new bridge contact at the top of the photo clearly shows what the contacts should look like.
