Modernization of Mill Power Systems for Better Control and Visualization

Brian Clark

Tim Burttram

AISTech 2014 – The Iron & Steel Technology Conference and Exposition

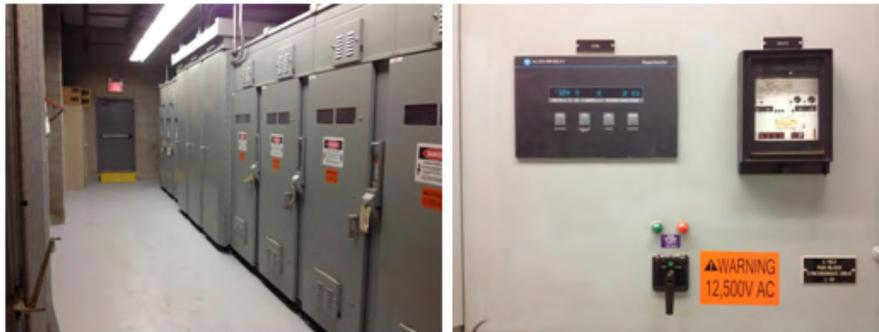
The first microprocessor-based relays were installed in the Rolling Mill 2 (RM2) main metal-clad switchgear shown in Figure 1. These microprocessor-based relays replaced electromechanical relays as well as power metering units installed in the switchgear by the original equipment manufacturer.

Figure 1. RM2 switchgear and original instrumentation

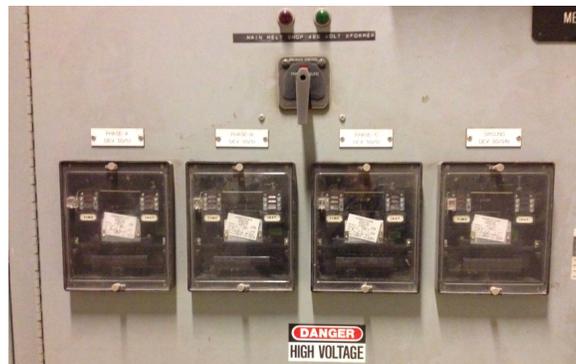
The original switchgear relaying, shown in Figure 2, consisted of one relay per phase plus one relay for ground detection.

Figure 2. Original melt shop relay configuration (protecting only one circuit)

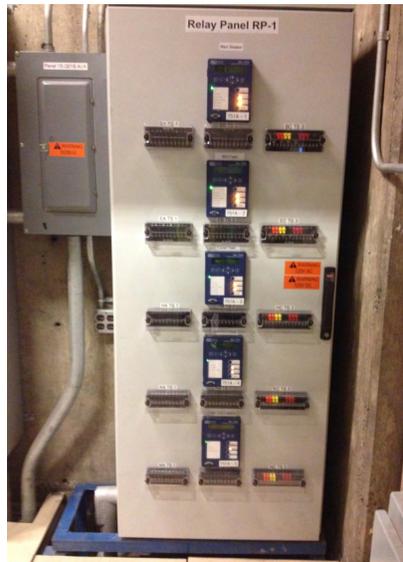
All of the functionality of the four relays per breaker is now contained in one new relay per breaker, as shown in Figure 3.

Figure 3. Melt shop switchgear relay panel (with complete protection for five circuits)

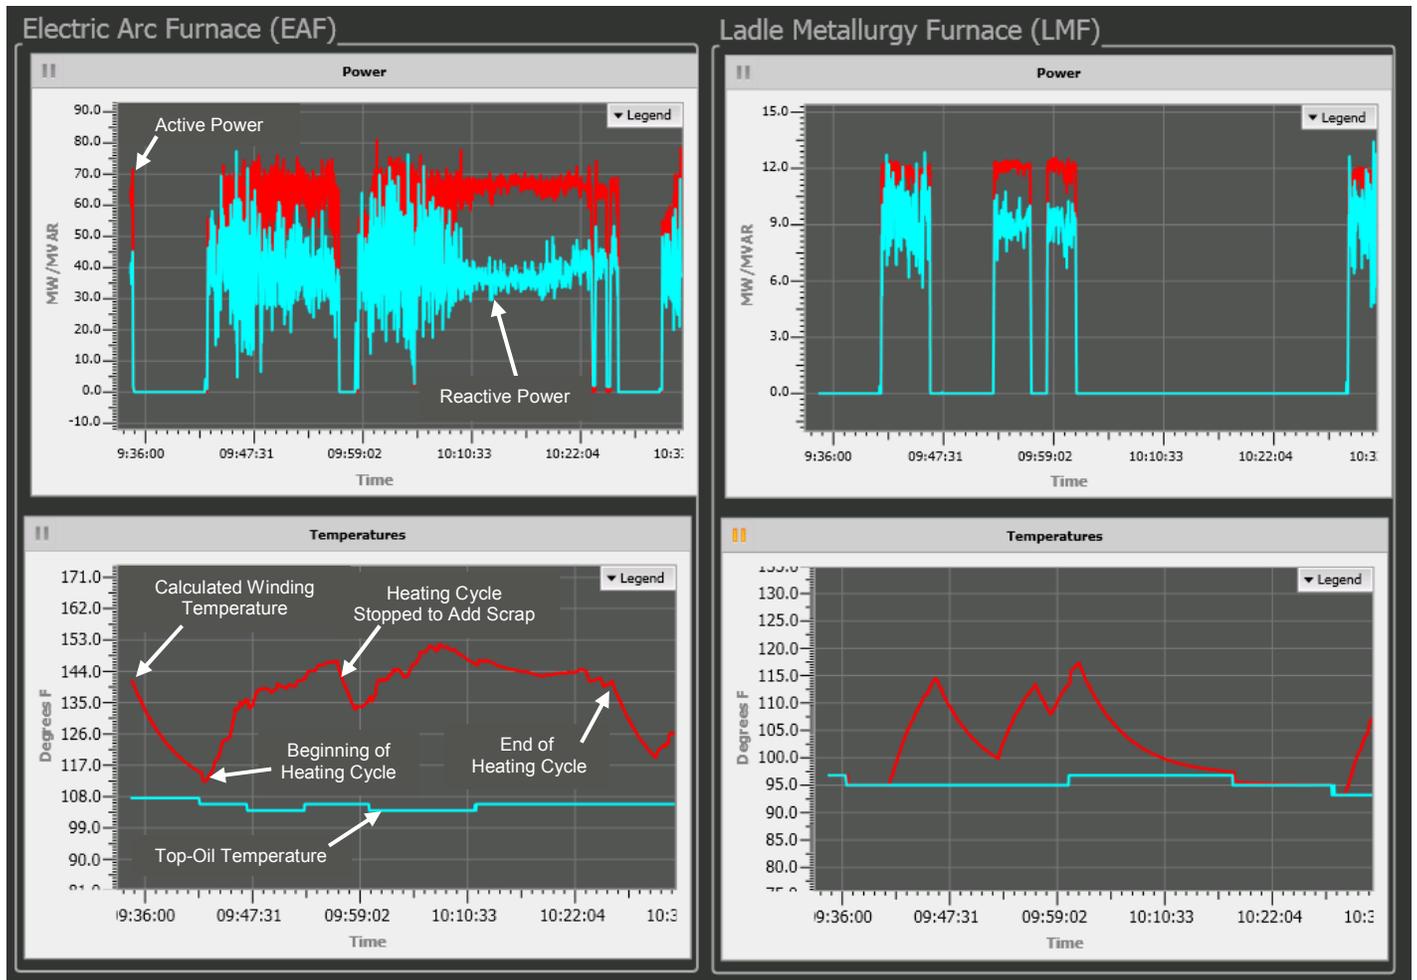
Figure 4 shows the HMI screen for the EAF and LMF power and temperature trends for one hour. In the upper plots, the top lines indicate active power while the bottom lines indicate reactive power for the respective furnaces. In the lower plots, the top lines show the calculated winding temperature while the bottom lines indicate the top-oil temperature. The water-cooled oil temperatures are relatively stable while the winding temperatures rise quickly when furnace heating takes place. These plots can be viewed by the production staff (or any other authorized personnel throughout the mill) to monitor these critical furnace parameters and optimize the heat processes for best process efficiency while protecting the transformers.⁵

Figure 4. Furnace power and temperature trends shown on HMI screen

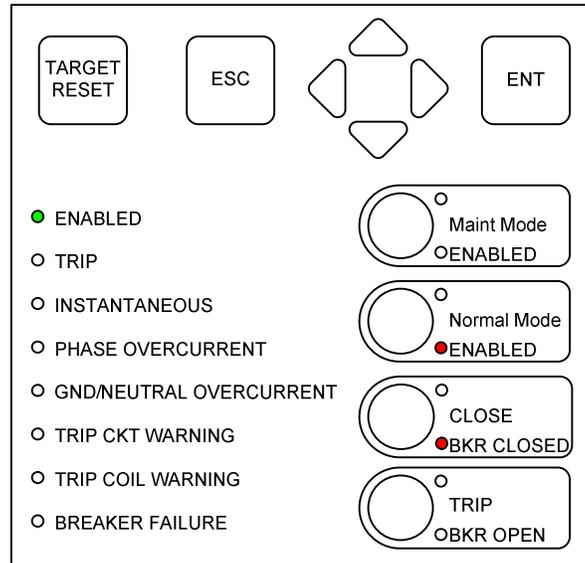
Each new microprocessor-based relay has pushbuttons that allow the operator to open or close the associated breaker from the relay front panel, thereby allowing personnel to be located a safe distance from the switchgear when the breaker is being opened or closed. Personnel can also place the relay into maintenance mode or normal mode from the relay front panel. Light-emitting diodes (LEDs) are programmed to indicate the status of the breaker (open, closed, or one of several warning states) and the mode of operation (see Figure 5).

Figure 5. New microprocessor-based relay front panel

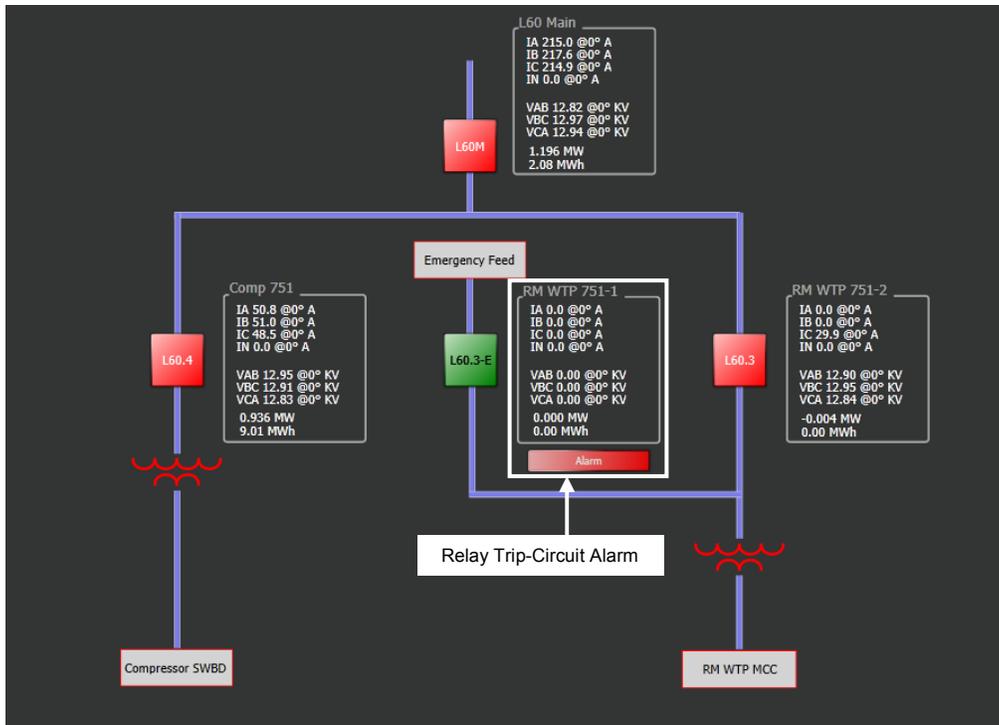
Figure 6. System one-line diagram on HMI display

The relay in Figure 6 is shown in the alarm state because it is not receiving feedback from the trip coil circuit. In this case, the relay correctly detects and indicates a problem with the trip coil circuit because the breaker is racked out and the breaker power connector is not connected.

All of the new relays are connected via the plant fiber backbone to the SCADA server and the automation controller. The server downloads and archives event information and waveform captures from all of the relays. The HMI displays one-line power distribution drawings with relay statuses as well as real-time three-phase voltage, current, and power, as shown in Figure 6. This provides a visual indication of the operational status of each relay. Because the HMI is web-based, it is viewable from any computer

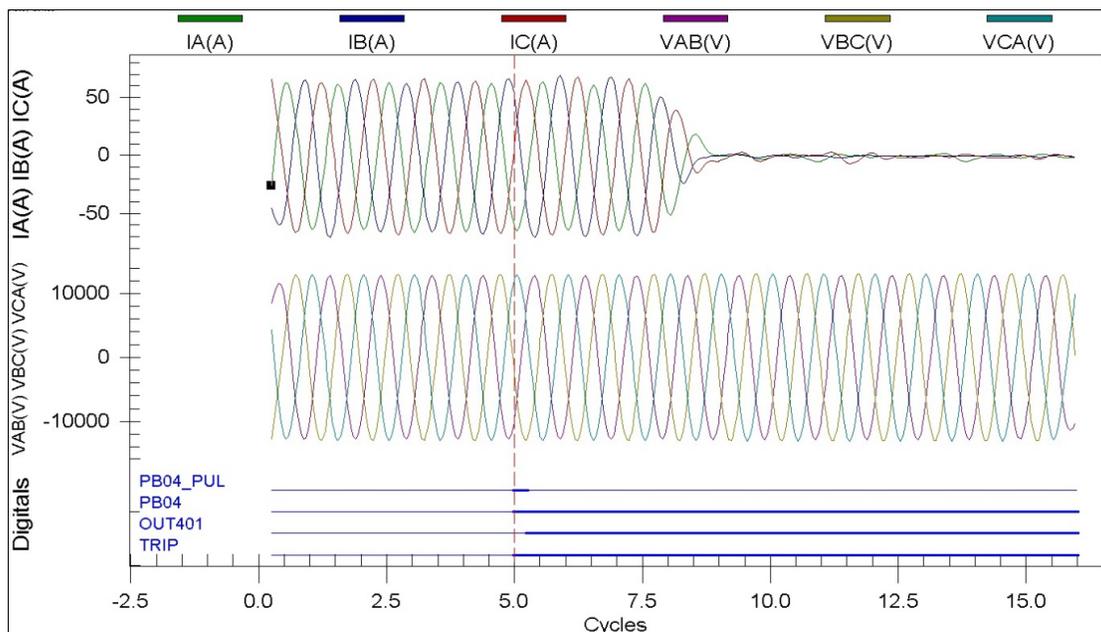
Figure 8. Analog waveform capture with time-aligned digital signals for manually operated trip of entire melt shop

Date	Time	Element	State	Comment
08/14/2013	20:21:30.186	TRIP	Asserted	NA
08/14/2013	20:21:30.186	PB04	Asserted	Technician pressed {TRIP} Pushbutton 4 (PB04) in error.
08/14/2013	20:21:30.190	OUT401	Asserted	Entire melt shop tripped unnecessarily.

This information showed that the extent of the blackout was caused by human error, not additional faults. Knowing this prevented any further delay in restoring power to the affected areas of the plant. In addition, the data were used to train electrical department staff on how to appropriately respond to any future events.
