Line Current Differential Relay Response to a Direct Lightning Strike on a Phase Conductor

Matthew Boecker and Genardo Corpuz
Lower Colorado River Authority

This paper was presented at the 71st Annual Conference for Protective Relay Engineers, College Station, Texas, March 26–29, 2018, and can be accessed at: <https://doi.org/10.1109/CPRE.2018.8349805>.

Abstract—This paper describes an event in which lightning struck and discharged current into the phase conductor of a 345 kV transmission line. The magnitude of the lightning discharge was insufficient to lead to a flashover (line insulation breakdown). The paper examines and explains the response of two different line current differential protective relays to this event that was inside their zone of protection.

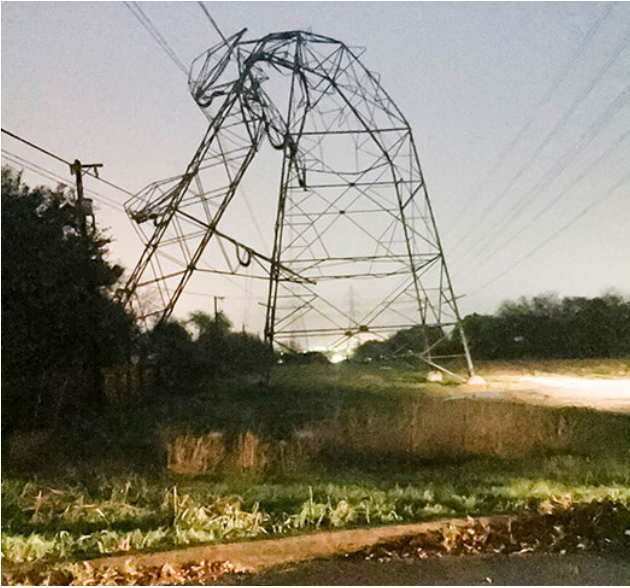
On February 19, 2017, powerful storms and tornadoes swept through the state of Texas, damaging homes and properties in their path and leaving thousands of residents without power [1]. At the height of the storm, severe wind gusts bent at least one high-voltage transmission tower in half, as shown in Fig. 1.

Fig. 1. High-voltage transmission tower damaged during storm

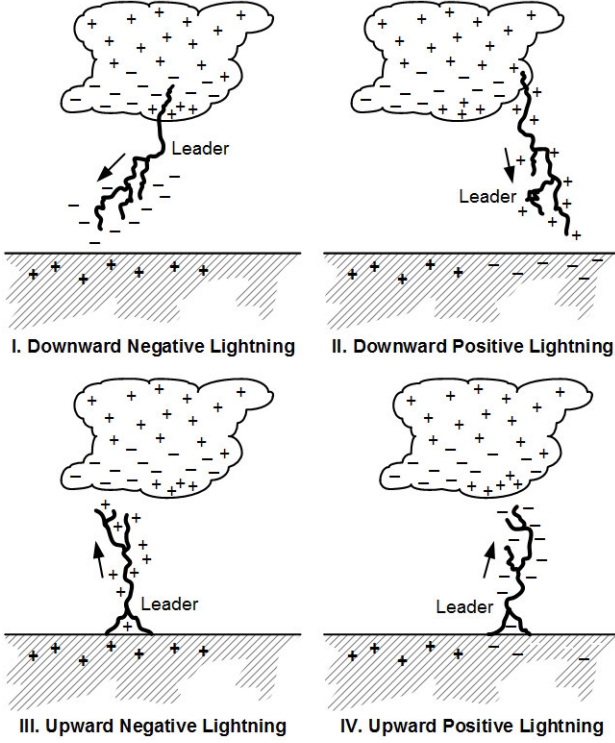
Cloud-to-ground lightning strikes constitute about 25 percent of all lightning strikes and are a cause for concern because they can disrupt power systems [3] [4]. Such strikes can transfer a positive or negative charge to the ground and may originate from the cloud or from the ground. Consequently, cloud-to-ground lightning has four discharge types, as shown in Fig. 3.

Fig. 3. Types of cloud-to-ground lightning

Almost 90 percent of all cloud-to-ground lightning strikes belong to Category I (negative downward), where an initial breakdown inside the cloud leads to a strong concentration of negative charge at the base of the cloud. The negative charge starts ionizing the air and a column of negative charge, referred to as the leader, starts moving from the cloud toward the ground. As the leader approaches ground, it induces streamers of opposite charge to rise from the ground toward the stepped leader. When the leader and streamer meet, the path between the cloud and ground is complete and a high-discharge current, known as the return strike, flows between the cloud and the ground. The median current value of the first strike is typically around 30 kA. The initial strike may be followed by several subsequent strikes that do not necessarily land at the same location as the original strike. The median current value of subsequent strikes is much lower than the first strike, typically 12 kA. A flash, which is a collection of three to five strikes, can last up to half a second.

Positive downward cloud-to-ground flashes (Category II) deliver a positive charge to the ground and are not very common. Tall objects with sharp corners at the top or mountain peaks can often initiate upward moving leaders, which can be positive or negative (Category III or Category IV). When those leaders reach the cloud, a lightning discharge follows. Since transmission lines and substations do not have sharp corners at the top, it is more common for them to experience downward flashes [5].

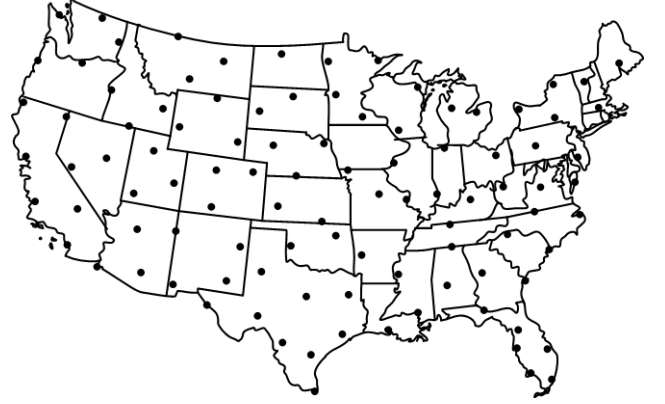
Vaisala, Inc., owns and operates the NLDN, which monitors all lightning activity in the U.S. 24 hours a day, 7 days a week. It does so by deploying more than 100 lightning detection sensors at strategic locations across the U.S., as shown in Fig. 4.

Fig. 4. Lightning sensors deployed by Vaisala across the U.S. [6]

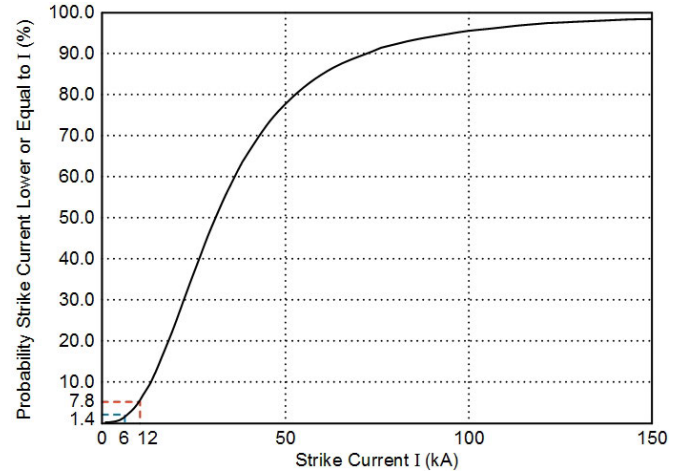
Comparing this result with the strike current distribution given in [12] and shown in Fig. 6 allows us to determine that lightning strikes with current lower than or equal to 6 kA occur in approximately 1.4 percent of all lightning strikes. With the cutoff limit set to 12 kA (critical flashover current level I_C calculated for this line), the probability curve climbs to 7.8 percent.

Fig. 6. Lightning strike probability as a function of strike current

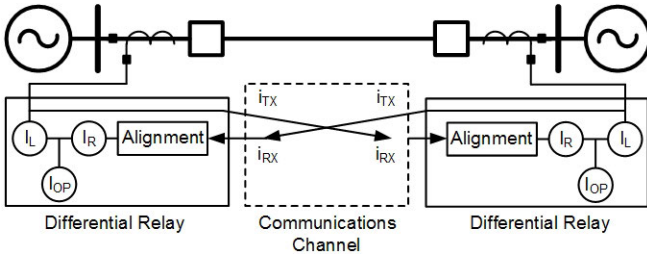
When applied to transmission lines, current differential protection requires a communications channel to receive currents from the remote terminals. Fig. 7 shows differential protection being applied to a two-terminal transmission line. One relay measures current at the local terminal while the other relay measures current at the remote terminal. The two relays then exchange current information over the communications channel to calculate the difference current (I_{OP}). If I_{OP} is greater than a pickup threshold and the ratio of the remote current to the local current plots outside the restraining region shown in Fig. 8, the relay operates. Refer to [14] for more information about differential relay principles and their application.

Fig. 7. Example two-terminal system

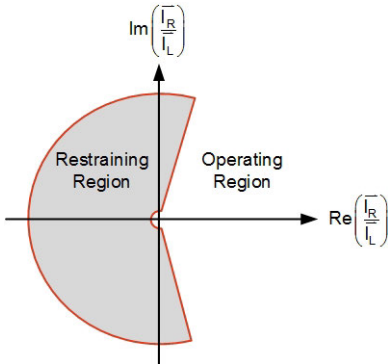
Fig. 8. Line current differential relay characteristic

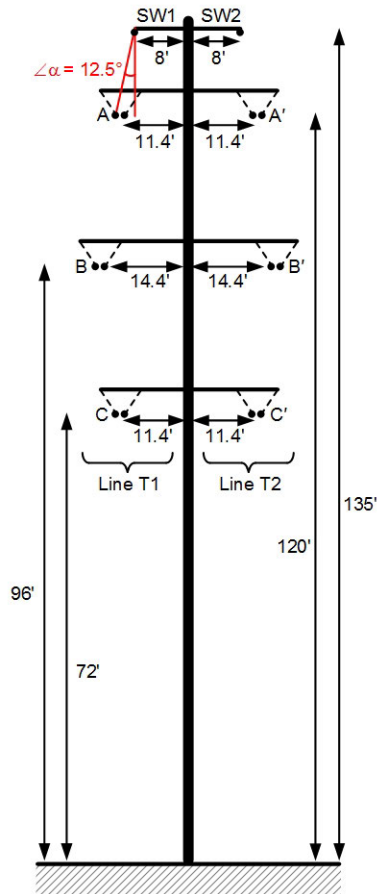
Transmission lines T1 and T2 are 5.6 miles long and are constructed as a double circuit on a single tower, as shown in Fig. 10. Since the state of Texas experiences significant lightning activity, the transmission lines are protected by two shield wires. The transmission line towers are relatively tall, with shield wires at 135 feet above ground. The shielding angle (α) of 12.5° far exceeds the commonly used 30° angle requirement. More precise calculations of shielding angle that consider terrain, tower height, and the lightning current level can be found in [12] and [18].

Fig. 10. Tower geometry of the 345 kV transmission lines between Substations Charlie and Delta

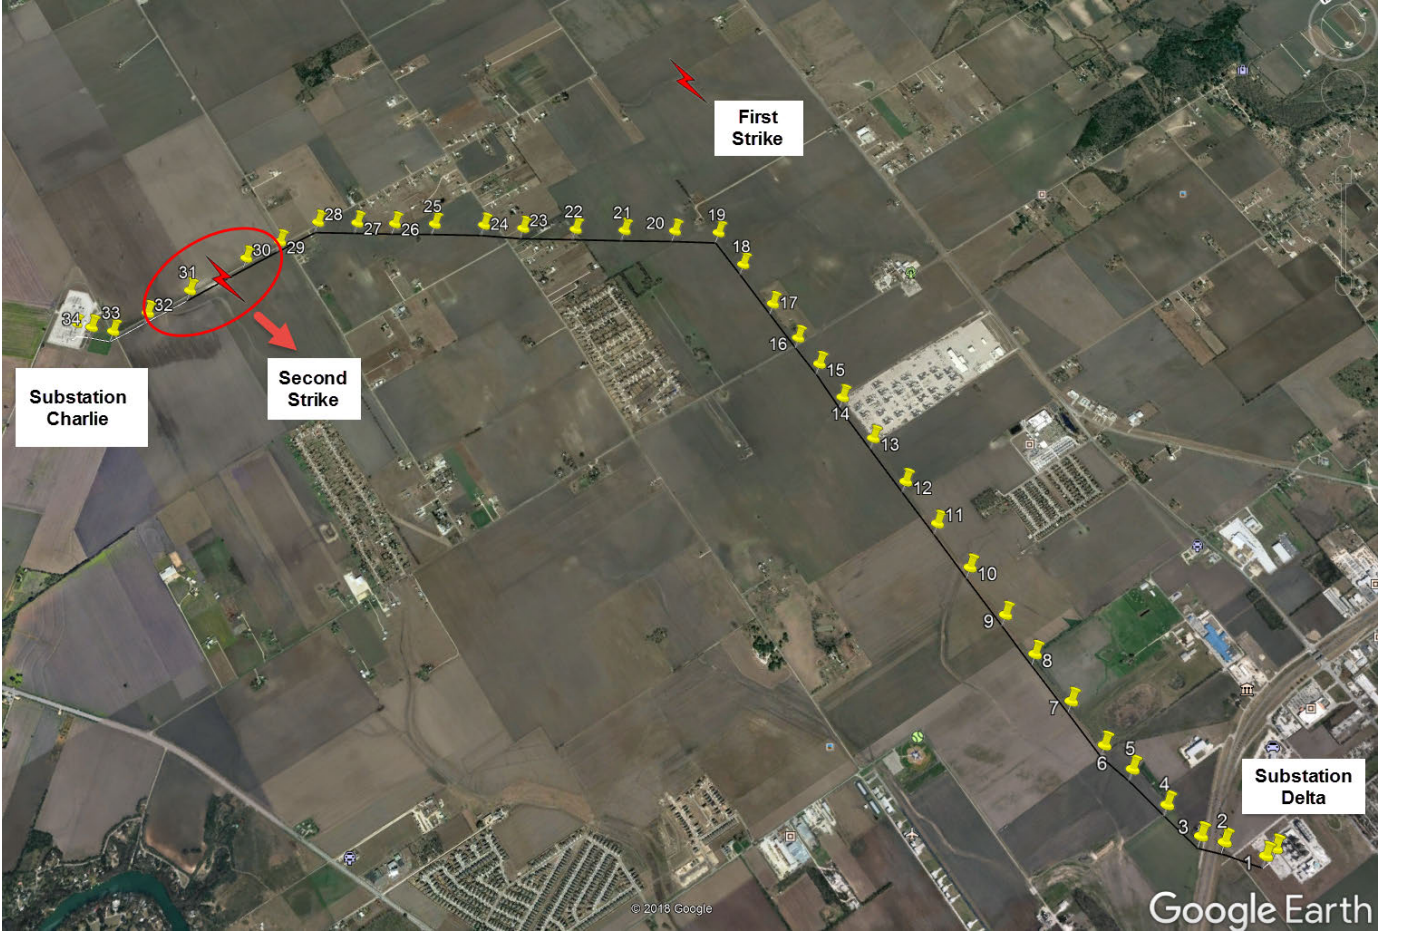
Fig. 11. Lightning activity detected at the time of the relay operation (double-circuit towers carrying Lines T1 and T2 are shown as yellow pushpins)

One strike occurred at 23:29:06.798 at a location far from the transmission line, as shown in Fig. 11. The peak current delivered by the strike was reported to be 12 kA, ± 15 percent. The 15 percent median error of the sensors in estimating the peak current was reported in [20]. Another strike occurred at 23:29:07.196. The peak current delivered by the strike was reported to be 6 kA, ± 15 percent. The second strike was found to have contacted the ground somewhere inside the detection ellipse drawn to match the NLDN 99 percent confidence level.

Because transmission line towers 29 to 32 are within the confidence ellipse, it is clear that the second strike played a key role in the relay operation. This theory is corroborated by the time stamp of the relay operation at 23:29:07.116028, which coincides with the second event. The lightning strike location estimate from the TWFL in the Type B relay is 0.5 miles. This translates to a location between Tower 31 and Tower 32, which falls inside the detection ellipse drawn in Fig. 11 and further backs up the theory.

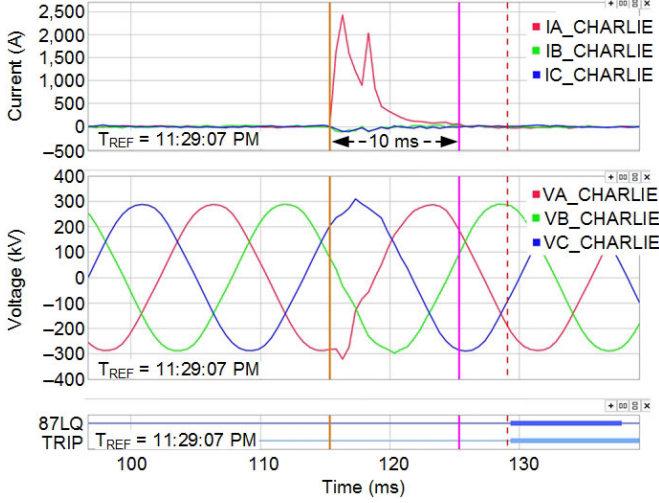
Because the generating station at Substation Delta was offline at the time of the event, we look at the raw data captured by the Type B relay at Substation Charlie. The voltage and current waveforms are shown in Fig. 12. The Type B relays in this event were programmed to save data at 2 kHz (these relays allow users to save data at a sampling rate of up to 8 kHz). While the lower sampling rate is adequate for analyzing 60 Hz events, it is not ideal for visualizing fast transients.

Fig. 12. Event data recorded at Substation Charlie with a resolution of 2 kHz

Starting at 23:29:07.116028, the relay at Substation Charlie observed a high current on Phase A for a very short duration. The negative-sequence differential element (87LQ) operated on this unbalance and tripped the line 14 milliseconds later. The current spike lasted for about 10 milliseconds and was not followed by a 60 Hz current, meaning that the lightning strike in this event did not flash over and cause a power system fault. This is further corroborated by the increase in Phase A voltage at the time of the current spike. For a conventional 60 Hz short-circuit fault, we expect the voltage of the faulted phase to sag, not swell. The result is also consistent with the theory that lightning strikes with currents less than the critical current do not cause a flashover. Recall that the NLDN reported the peak current of the lightning strike to be approximately 6 kA, ± 15 percent, which is less than the critical current for this line (12 kA).

The waveform of the Phase A current leaves quite a few unanswered questions about the real nature of the event. Correlating the time stamp of this event with the NLDN report in Table II allows us to say with confidence that this event had something to do with lightning. But, it also leaves us with the realization that the 2 kHz recording in Fig. 12 does not contain sufficient information about the lightning strike. To make things more confusing, lightning strike current is normally much shorter than the recorded 10 millisecond spike. As with any natural process, lightning current varies a lot but is typically represented with an exponential wave having a $1.2 \mu\text{s}$ rise time and $50 \mu\text{s}$ fall time. This duration is almost 200 times shorter than the event recorded in Fig. 12.

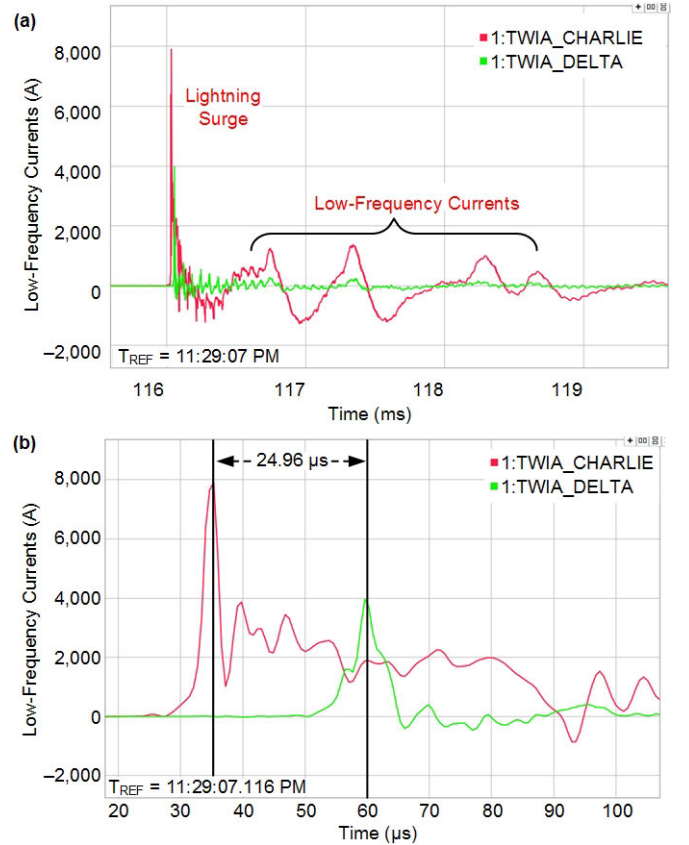
Fig. 13a shows the Phase A traveling-wave currents that the Type B relays recorded at both ends of the line. For ease of use, they have been plotted on the same graph. Data are synchronized via GPS with submicrosecond accuracy, allowing an accurate representation of the wave travel times. Fig. 13b zooms into the initial wave received at both terminals. Notice that both terminals recorded a high-current pulse on Phase A. Traveling waves on Phases B and C had lower magnitudes and polarities opposite to those of Phase A, confirming that this was a direct strike to the Phase A conductor (shielding failure) [21].

Fig. 13. Phase A traveling-wave currents at both line ends (a) and a zoomed-in view of the first strike (b)

Another point of interest is that the current traveling waves (TWIA) recorded at either terminal of the transmission line have the same polarity, and the time difference ($\Delta t = 24.96 \mu\text{s}$) between the arrival of the two current TWs at their respective terminals is less than the traveling-wave line propagation time ($\text{TWLPT} = 31.15 \mu\text{s}$). This indicates that the lightning strike was inside the zone of protection between the line terminals.

We now focus our efforts in understanding the succession of low-frequency traveling-wave currents seen by the relay at Substation Charlie (see Fig. 13a) after the initial lightning strike. The currents get slowly damped but remain visible for a full millisecond. Additional discussion showing how a 50 μ s lightning impulse got converted into a low-frequency transient lasting long enough (10 milliseconds) for the protection elements to pick up is given in the next subsection.

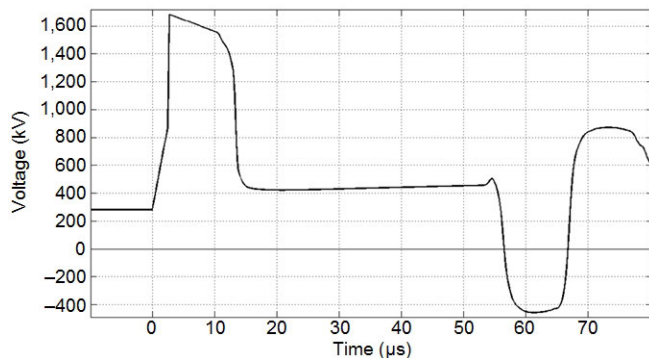
A lightning strike into the Phase A conductor was simulated using a CIGRE (International Council on Large Electric Systems) lightning current source model. The peak magnitude of the injected current is 8 kA. The line characteristic impedance (Z_c) for the simulated lightning strike, simulated by a 1.2/50 μ s pulse, is approximately 350 Ω . Therefore, an 8 kA, 1.2/50 μ s lightning strike develops a peak voltage of approximately 1,400 kV. The lightning strike was simulated to occur at the same instant the positive peak voltage occurred on Phase A (≈ 280 kV). Therefore, the peak instantaneous voltage is approximately 1,680 kV. The simulated lightning strike was injected at the same location as the second lightning strike shown in Fig. 11. The voltage profile at the point of current injection over a period of 80 μ s is shown in Fig. 14.

Fig. 14. Voltage profile at the current injection point.

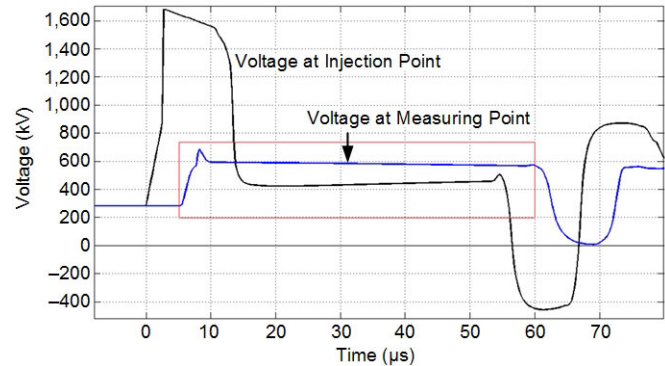
Before the voltage traveling wave reaches the line terminal, it passes a surge arrester. The arrester clips and clamps the magnitude of the voltage traveling wave and diverts some of the injected current to ground. The voltage profile at Substation Charlie is shown in Fig. 15 (blue). The voltage at the injection point (black) is also shown.

Fig. 15. Voltage profile at the current injection point (black) and at Substation Charlie (blue)

From Fig. 15, the impact of the surge arrester can be seen; it clamps the magnitude of the voltage traveling wave to approximately 600 kV. Since the line is very short (31.15 μ s), the arrester action is soon seen along the entire line length. Note that the voltage shown in Fig. 15 is the sum of the incident and reflected voltage. The power system impedance behind the relay measuring point at Substation Charlie determines how much of the incident voltage and current traveling waves are transmitted and reflected. The other terminal of the transmission line, Substation Delta, is effectively open. As a result, nearly all of the incident voltage at Terminal Delta is reflected into the line. The step change in terminal voltage at Substation Charlie, shown inside the red box in Fig. 15, is short-lived but stimulates (excites) the power system (resistors, inductors, and capacitors) behind the Substation Charlie line terminal. The low-frequency traveling-wave currents seen by the relay at Substation Charlie (Fig. 13a) are the response of the power system to that voltage stimulus. Since the generating plant end of the line (Substation Delta) is effectively open, we can see that there is no low-frequency current exiting this end of the line. Therefore, all of the low-frequency current measured at Substation Charlie is seen by the relays as differential current (difference between the red and green traces) originating inside the T1 line protection zone.

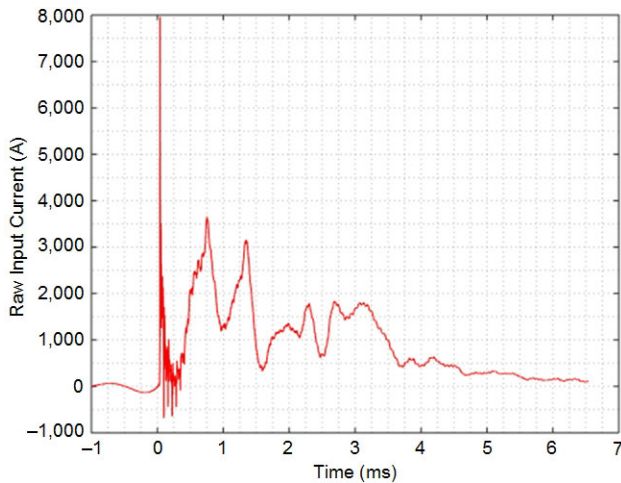
To understand the relay response, we attempted to reconstruct the actual current waveform on the power system and at the relay inputs before any kind of filtering. To do this, we upsampled the 2 kHz raw current data to 1.5625 MHz and combined it with the traveling-wave data. The result is shown in Fig. 16.

Fig. 16. Current measured by the relay at Substation Charlie before any filtering

If we do a frequency spectrum of the current in Fig. 16, we obtain the data shown in Fig. 17.

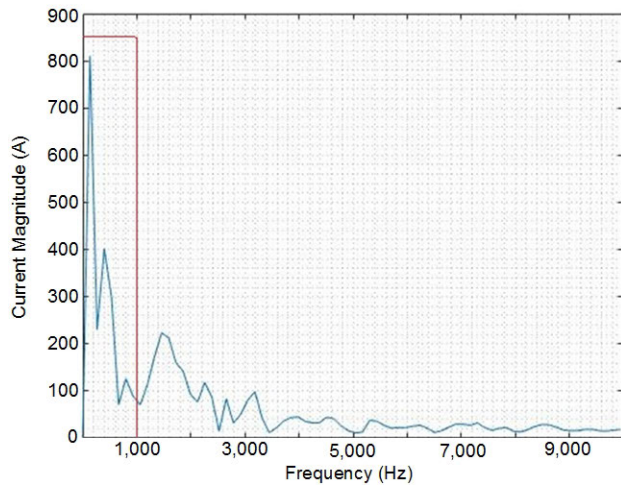
Fig. 17. Frequency spectrum of the current measured at Substation Charlie (note magnitude of the current below 1 kHz, shown inside the red box)

From this we can verify that the response current caused by the voltage stimulus contained frequencies from dc to tens of kilohertz, with portions of the higher frequency current transient being diverted by the surge arrester. The relays' analog and digital antialiasing filters effectively attenuate frequencies above 1 kHz. However, currents below 1 kHz (inside the red box in Fig. 17) pass through the antialiasing filters unaffected. Fig. 18 shows the output after the current in Fig. 16 has passed through the digital antialiasing filters in the relay.

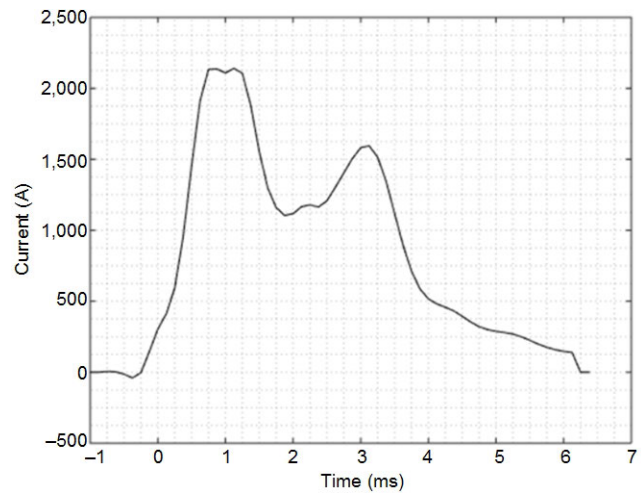
After the current has passed through the digital antialiasing filter, the currents are input into a DBPF, and from this the nominal frequency component of the signal is extracted (in this case, nominal frequency is 60 Hz). Fig. 19 is the output of the 60 Hz DBPF at Substation Charlie. As noted earlier in this section, the line terminal at Substation Delta was open. This means there was very little current measured at this line terminal. Therefore, the phase differential current and the resulting negative-sequence differential current are approximately equal to the current measured at Substation

Fig. 18. Current after being filtered by the antialiasing filter (current is fed into DBPF)

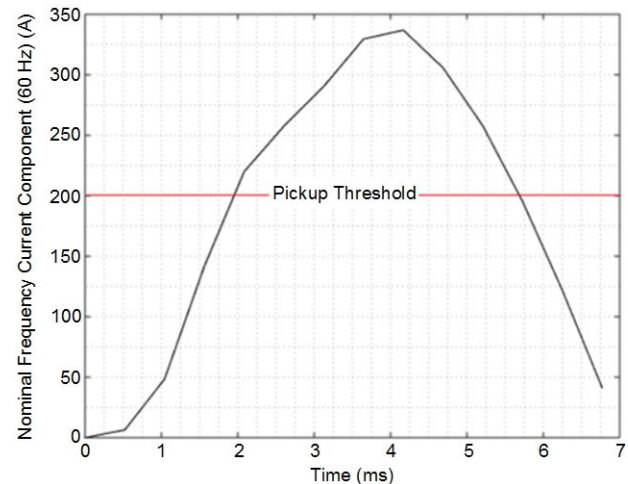
Charlie, as shown in Fig. 19. Because the pickup of the negative-sequence differential element was set very sensitively at 200 A primary, the measured negative-sequence differential current exceeded the pickup. We study the relay operation in more detail using the filtered event report in the following subsection.

Fig. 19. 60 Hz output from the DBPF

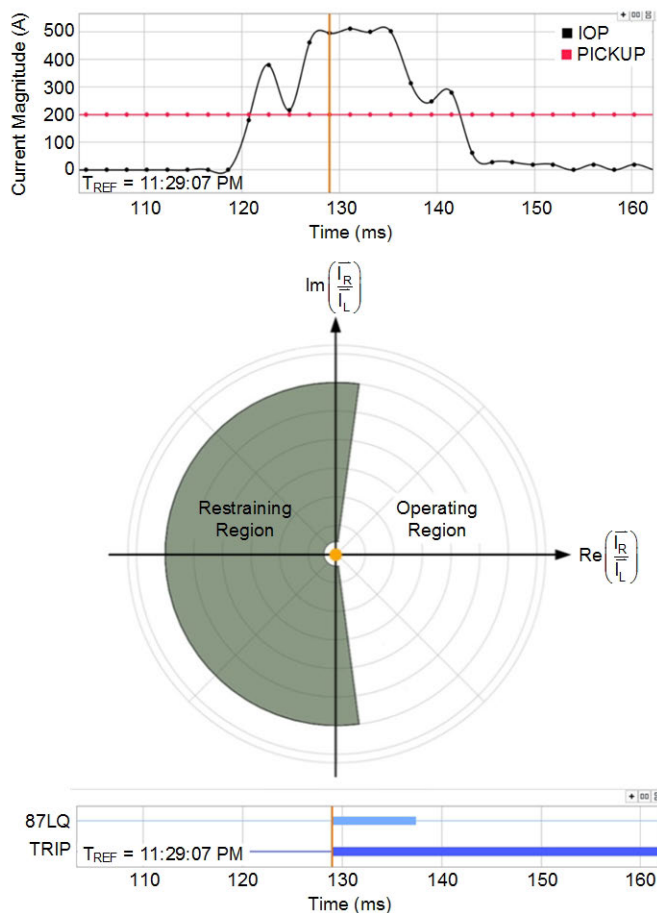
We use the filtered event report to explain the trip issued by the Type B line current differential relay. The lightning strike was inside the zone of protection. As a result, the external fault detector did not assert and the element continued to be in the normal/sensitive mode. Because the negative-sequence differential current (I_{OP}) measured by the relay during the disturbance was greater than the pickup setting of 200 A and the current ratio plotted outside of the restraining region, as shown by the orange point in Fig. 20, the negative-sequence differential element (87LQ) asserted instantaneously and caused a trip.

The Type A relays also measured the same negative-sequence difference current, but the inherent time delay in the negative-sequence differential element logic prevented the Type A relays from operating.

Fig. 20 Analysis of the Type B relay operation

If the relay action is judged to be incorrect, the following two setting changes will prevent the negative-sequence differential element from tripping the line for similar events in the future.

- Increase the pickup of the negative-sequence differential element. To do this, the user will have to study the impact of a direct lightning strike to a phase conductor that does not result in a flashover (lightning strike below 12 kA for this line) under different power system configurations, determine the maximum negative-sequence current possible for all the scenarios, and set the pickup above this level. This is a nontrivial task and requires some detailed study. Furthermore, the task cannot be generalized and is highly dependent on the line construction, line length, terrain, and the lightning risk in the area. It is also important to point out that increasing the pickup could lead to losing dependability for high-resistance faults.

- Delay the negative-sequence element by half or one power system cycle, the only caveat being the purposeful delay of the negative-sequence element for internal faults. This may be an acceptable compromise because the purpose of the negative-sequence element is to detect high-impedance faults. For these fault types, sensitivity is more important than speed because these faults do not impact power system stability or damage power system equipment.
