# Event Analysis Tutorial

## Part 2: Answer Key

David Costello, Schweitzer Engineering Laboratories, Inc.

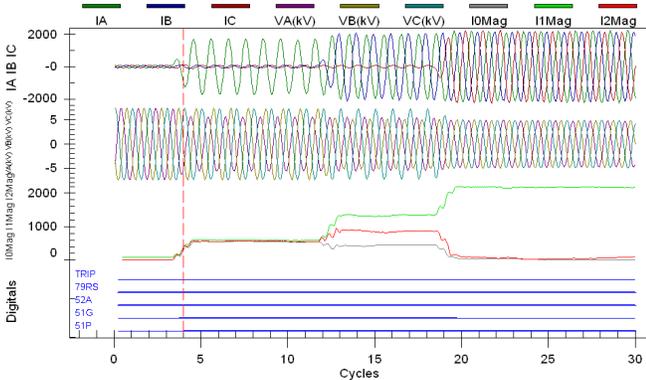
Fig. 2. Distribution Feeder Fault (2 – Distribution Feeder Fault 351A.cev)

Note in Fig. 1 that the phase fault current is largest during the single-line-to-ground fault period. In Fig. 2, the phase fault current is largest during the three-phase fault period.

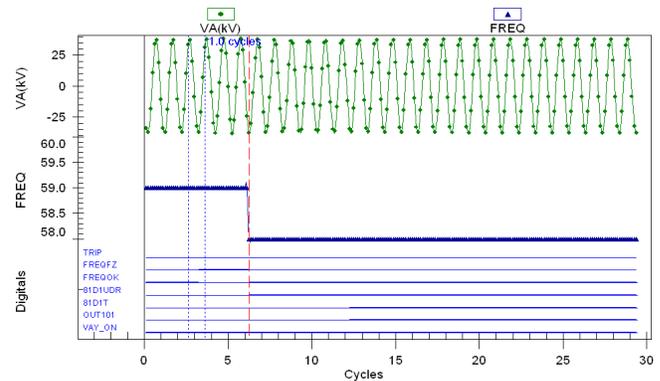
Fig. 4. Frequency Test 2 (3 – Frequency Load Shed Test Two 451-5.cev)

- III-c Is a step change in frequency an appropriate test method for an underfrequency load-shedding application?  
 No. In a real power system, frequency changes ramp but do not step change. In some relays, frequency tracking algorithms have a maximum slew rate, above which the algorithm suspends frequency tracking. In a step change test, it is likely that the maximum slew rate will be exceeded. In Fig. 4, we can see the FREQOK bit drop out and the FREQFZ assert right at the point

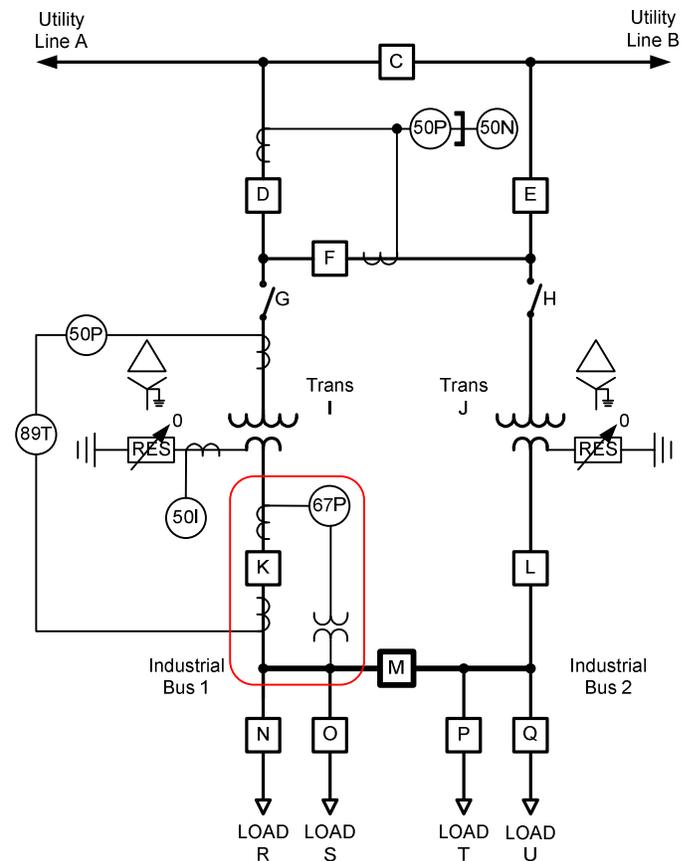
Fig. 5. One-Line Diagram for Directional Element Operation

The utility had a lightning arrester failure at a customer-owned substation several terminals away from this plant. The 67P relay tripped for this fault.

- IV-d Is this relay tripping response expected or a misoperation? There was a fault on the utility system (which is a reverse fault to this relay). So, technically, the relay did as it was told: see the reverse phase or ground faults and trip. However, it was intended to trip after a fair time delay for reverse power flow or as backup for a high-side fault when the utility high-side breakers were open. The utility had a failure to clear the fault at high speed, so the prolonged fault time exposed this problem. It is safe to say no one intended this relay to be so sensitive and to see an LG fault several line sections away.

- IV-e What is the root cause? The problem for this application is the relay directional element sensitivity. An electromechanical phase relay directional element operates like a power meter. With high load INTO the plant during an external fault, the high load overpowers the reverse fault sensing, so the overall decision is forward. In SEL-351 Relays, the phase overcurrent element has two distinct areas of logic. First, high forward load into the plant exceeds the phase overcurrent magnitude pickup. Second, a separate directional element looks for the fault location. For unbalanced faults, the relay uses negative-sequence quantities, which are provided by unbalanced current flow through motors and other loads in the plant. In other words, forward load into the plant picked up the phase overcurrent element (magnitude sensor) and the reverse negative-sequence element saw the fault

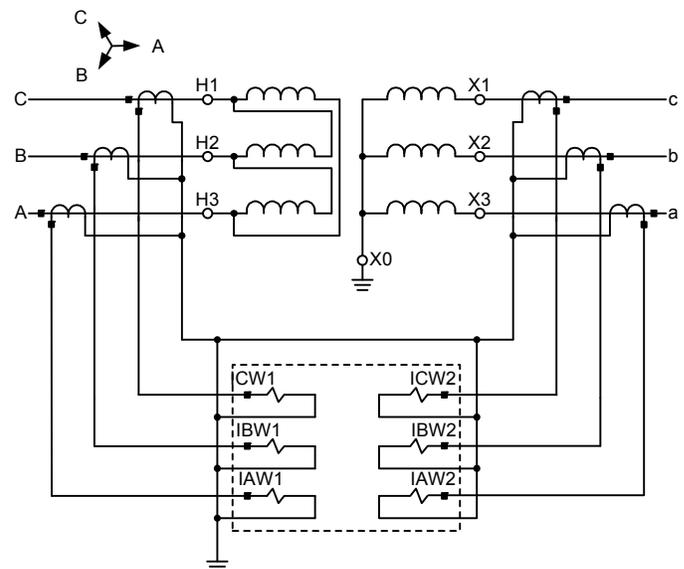
Fig. 7. Transformer Application

V-d Where was the fault (internal to the transformer or external to the protection zone)?  
 This is a radial system, and both high- and low-side current transformers (CTs) measured fault current. The phase angle relationships during the low-side LG fault correspond to the drawing in Fig. 7 and prove that the wiring is as expected.

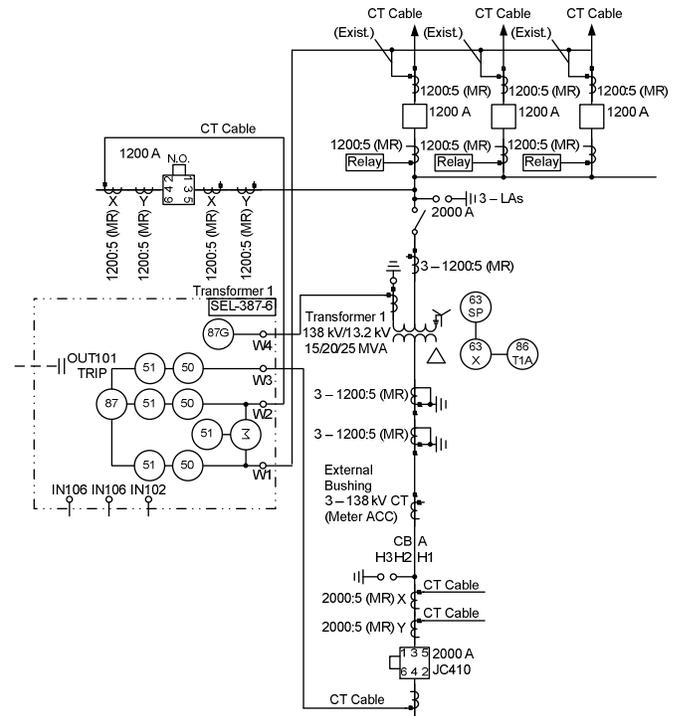
Fig. 10. REF Application

- VI-g A CT wiring problem is suspected. Can you prove which winding has the error?  
We know that the W1 feeder CT that experienced the external fault is connected correctly because the IB current on W1 is out of phase with the IB current on W3, the transformer high-side CT. That means the X0 bushing CT is connected backward or with incorrect polarity. The drawing in Fig. 10 is correct, so the error is in field wiring or the CT in the transformer tank is installed backward. Three recommended ways to ensure that the REF CTs are installed correctly are primary injection testing, standard CT polarity testing, or leaving the REF tripping disabled until the first system fault record can verify proper connections.

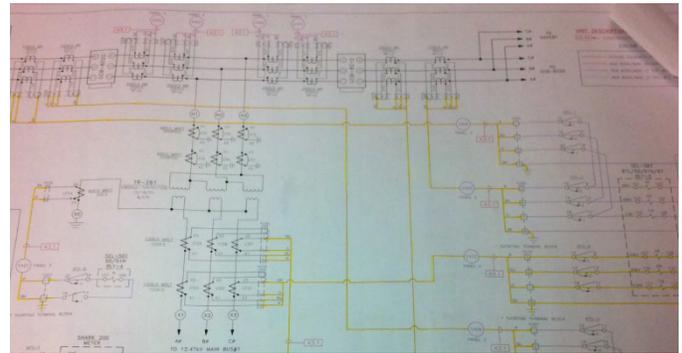
Fig. 12. Commissioning Example

Engineers and technicians were on-site to witness the energization of a new 138 kV/12.47 kV substation. After putting some load on the distribution feeders, they noticed that the differential current measured by the SEL-587 was quite high, as a percentage of restraint. The load was very small, and there was some debate as to whether the transformer was ready to be put into service.

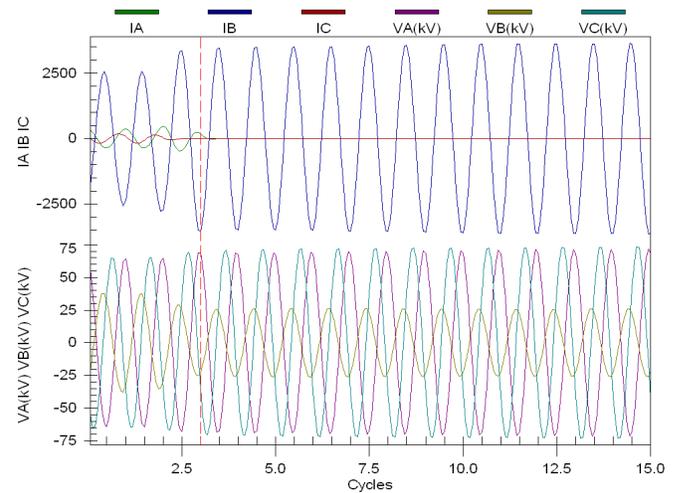
Fig. 20. Second Event, Terminal B (9 – B Delayed Fault Clearing 2nd Event 311C.cev)

Z4G picks up and starts timing. Notice the load current goes away (the remote end has opened).

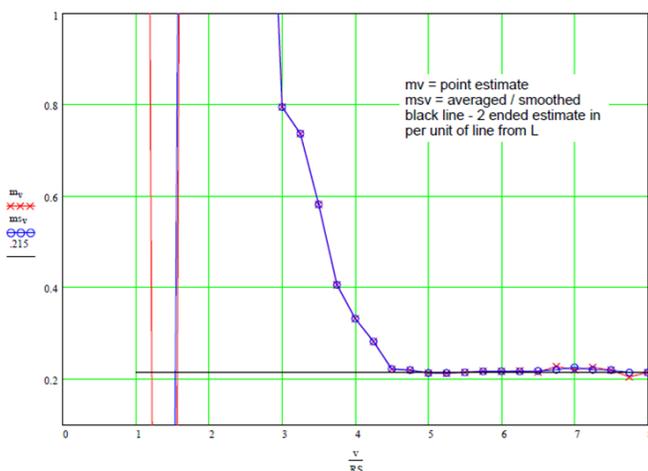
The two-ended result puts the fault at 0.215 per unit of the line from the left, or at 17.6 miles from Substation R. This precisely matches the physical evidence reported by the customer.
